RE: Site Inspection, Ziegler Chemical and Mineral Corporation, Ziegler Mine, M/047/013, Uintah County, Utah

Date of Inspection: October 9, 2002
Time of Inspection: 8:00 a.m. to 2:30 p.m.
Conditions: Clear, 60's
Participants: Stan Wagner, Ziegler; Doug Jensen and Paul Baker, DOGM

ATTACHMENT
Photographs
M/047/013, Ziegler Gilsonite Mine, Ziegler Chemical and Mineral

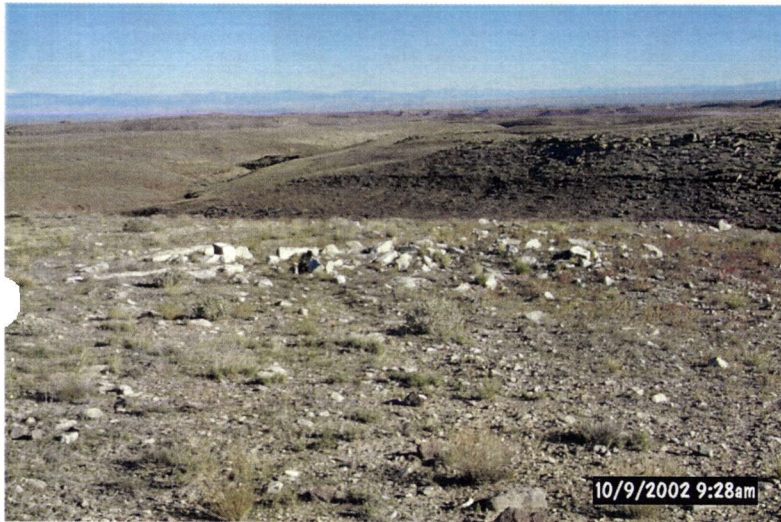
All of these sites are well graded to blend into surrounding terrain, and there were no visible hazards, such as open trenches or shafts. Vegetation at the sites was dominated by downy brome and kochia with some bee plant (*Cleome* sp.) and halogeton. Only the Cottonwood #3 site had some perennial species, including snakeweed, shadscale, and crested wheatgrass (Photo 1), but most of this site was dominated by introduced annuals (Photo 2). The Cottonwood #1 and 2 and Little Emma #7 sites are shown in Photos 3 and 4.

Photo 1. Cottonwood #3. This is an area with some perennial vegetation.

The operator needs to scarify the surface parallel to the contour and seed them this fall. If the surface is not deeply scarified, seed could be broadcast first, but if the operator rips or deep gouges first, the seed should be broadcast after the surface treatment. It is likely the soil in these areas has a good bank of weed seeds, so revegetation with desirable species will be more difficult than it would have been if weeds had not been allowed to become established.

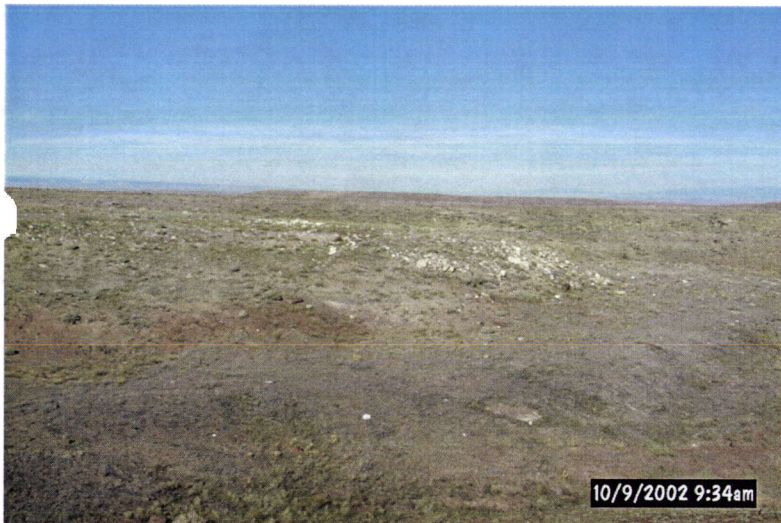
Photo 2. Cottonwood #3. The reclaimed area is the grayish area running just below the center of the picture.

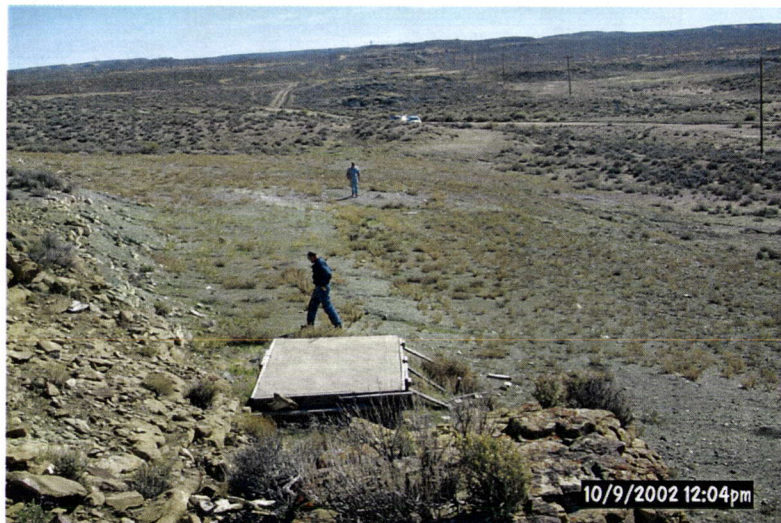
Photo 4. Little Emma 7. Vegetation in the disturbed area is mostly halogeton, cheatgrass, bee plant, and kochia.

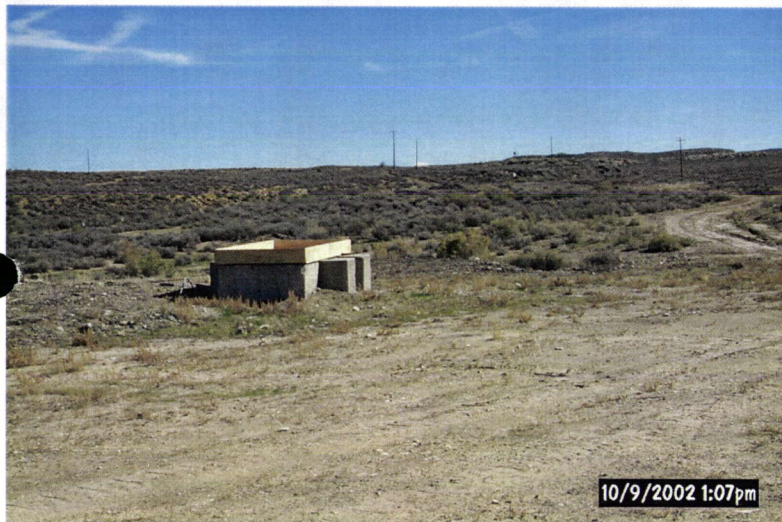
Photo 5. Little Emma #2.

In addition to the sites where Ziegler had requested release, we visited the Little Emma 2 and Sterling 1 sites. The operator is in the process of reclaiming Little Emma 2. Part of the cap was built, and there was a form for the portion that still needed to be poured (Photo 5).

The Bureau of Land Management has recently expressed concern about whether the concrete caps contain reinforcing steel. One of their inspection reports documents a site where no reinforcement was used. Mr. Wagner would like to be able to show that the caps have been reinforced, and we discussed a few ways of doing this. It would be possible to leave portions of the steel exposed, but this would cause the steel and concrete to deteriorate more quickly. What appears to be the best solution is to simply document the construction of each cap and to keep good records with photographs showing the steel before the concrete is poured.

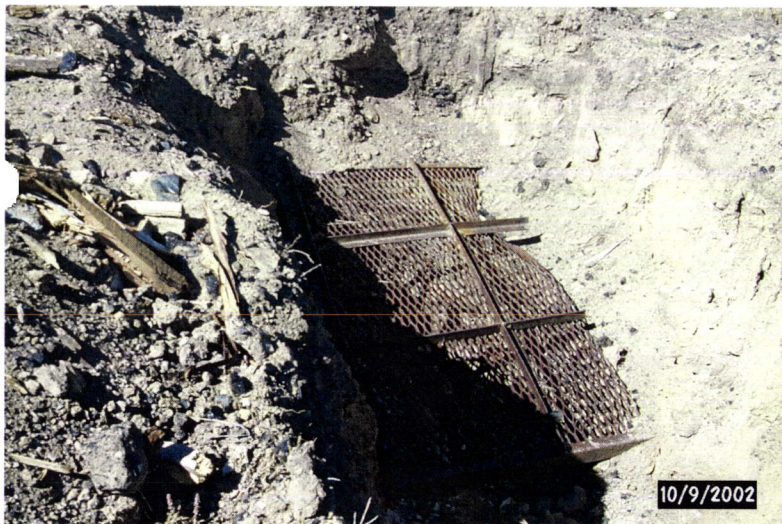
Photo 6. Sterling #1.

The Sterling #1 consisted of not much more than a hole in the ground about three feet deep (Photo 6).
